**Flood Control Project Maintenance
Levee Inspections**
LMA District Cover Sheet
Spring 2019 Levee Inspection Results

Reclamation District No. 0150 Merrit Island

Spring 2019 Levee Inspection Results

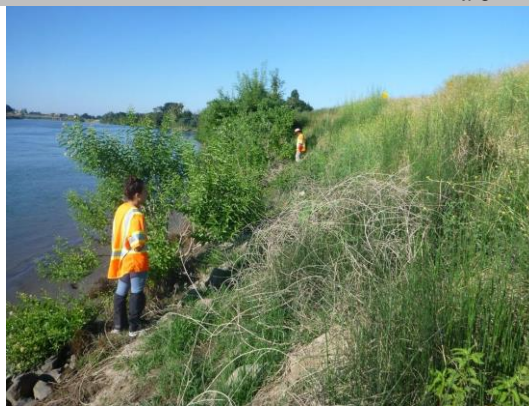
Photo 1 of 3 : LEVAL_SP_2019_286_1942.jpg

LM Start	0.11	Rating **	A/W	Issue No.	46
LM End	0.14	Issue Type +	Ma	Location *	WS
Category	Supplemental			GPS Latitude/Longitude	
				Start	End
Item	2017 Storm Damage			38.329369 °	38.329767 °
				-121.574936 °	-121.574589 °
DWR ID	DWR_RD0150_02_f_2017_46				
Comment Code					
Inspector Comment					
Levee Evaluation Comments					
Description: The flood damage consists of a waterside erosion approximately 185 feet long on the west (right) bank of the Sacramento River. See attached pages for photos.					
Site ID No:286					
Site Designation:LMA-112					
Repair Type: Erosion					
Rating: Area of Concern					
Field Date:7/17/2017					
Notes: Crown is a paved road. Scarps up to 3 ft deep, not fully vertical though. Area of concern because erosion is not very deep into prism.					
2019 Spring DWR Inspection: Erosion was not visible due to high water.

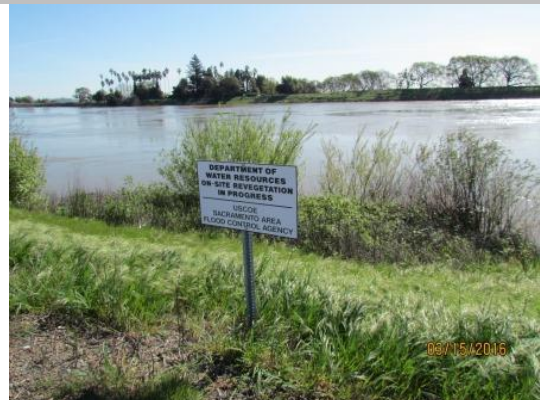
Photo 1 of 1 : SP_2019_RD0150_16_5_20190307_00002.jpg

View of the re-vegetation sign. Spring 2016

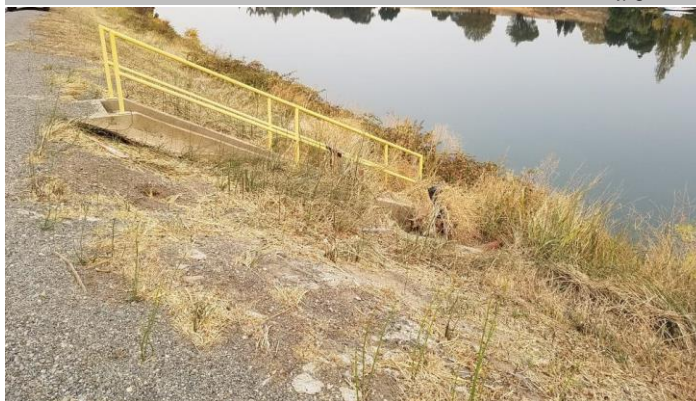
Photo 1 of 2 : SP_2019_RD0150_16_6_20190307_00003.jpg

LM Start	0.38	Rating **	M	Issue No.	6
LM End	0.38	Issue Type +	Ma	Location *	WS
Category	Earthen Levee			GPS Latitude/Longitude	
				Start	End
Item	Slope Stability			38.332598 °	38.332598 °
				-121.572179 °	-121.572179 °
DWR ID	DWR_RD0150_02_s _ 2012_6				
Comment Code					
S2 : Repair the levee slope damaged by foot traffic and prevent access where possible.					
Inspector Comment

View of slope instability around stairway. Fall 2018

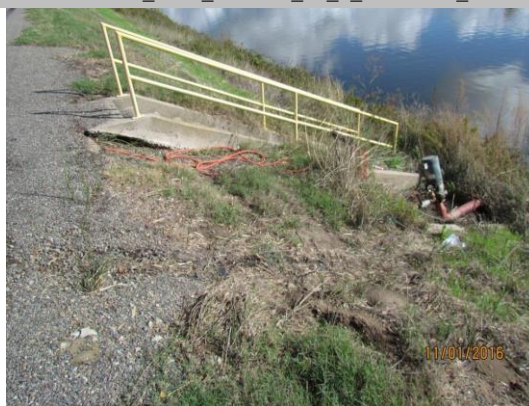
Photo 2 of 2 : SP_2019_RD0150_16_6_20190307_00004.jpg

LM Start	0.38	Rating **	M	Issue No.	6 (cont)	
LM End	0.38	Issue Type +	Ma	Location *	WS	
Category	Earthen Levee			GPS Latitude/Longitude		
				Start		End
Item	Slope Stability			38.332598 °		38.332598 °
				-121.572179 °		-121.572179 °
DWR ID	DWR_RD0150_02_s_2012_6					
Comment Code						
S2 : Repair the levee slope damaged by foot traffic and prevent access where possible.						
Inspector Comment

View of slope instability on the waterside of the levee. Fall 2016

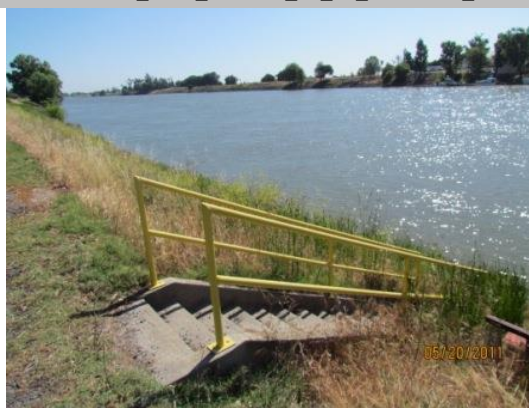
Photo 1 of 1 : SP_2019_RD0150_16_13_20190307_00007.jpg

LM Start	0.38	Rating **	M	Issue No.	13
LM End	0.38	Issue Type +	En	Location *	WS
Category	Earthen Levee			GPS Latitude/Longitude	
				Start	End
Item	Encroachments			38.332647 °	38.332647 °
				-121.572140 °	-121.572140 °
DWR ID	DWR_RD0150_02_s_2012_13				
Comment Code					
ST : Stairway					
Inspector Comment

A stairway was found on the waterside of the levee. The picture was taken from the crown looking upstream. Spring 2011

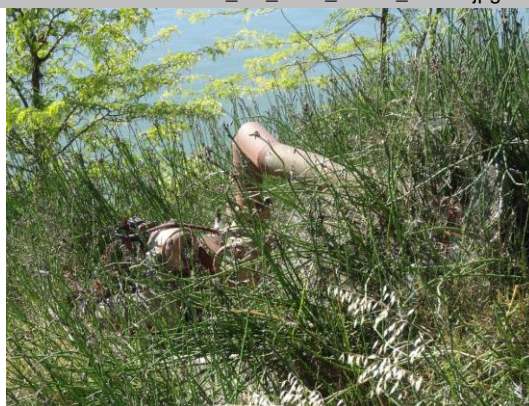
Photo 1 of 3 : UCIP_SP_2019_20267_34239.jpg

Comment Code					
Inspector Comment					
FS_ID:20267 DS_ID:22418 EP_NO: N/A Repair Type: Non-Urgent Crossing Status: Found UCIP Comments: - Abandoned pipe and pump.- Needs proper abandonment. FIELD_STRUCT_DESC: 6-inch steel irrigation discharge pipe and a 1-inch electrical conduit through the levee, invert elevation 3.5 feet below the crown. Pump and gate valve on the waterside (WS) slope. Electrical box on the WS slope. (Retention of an irrigation pumping plant, centrifugal pump, and gate valve on the WS with a 6-inch pipe through the levee authorized under Permit No. 9447, 1974 - Reuben A. Gentner). [Additional Reference(s): DWR Levee Log, 2005. USACE Sacramento O&M Manual 112, March 1957, (RM 34.47)]. FS Date: 8/27/2013

WS view: steel pipe and pump on levee slope. Dense vegetation on waterside.

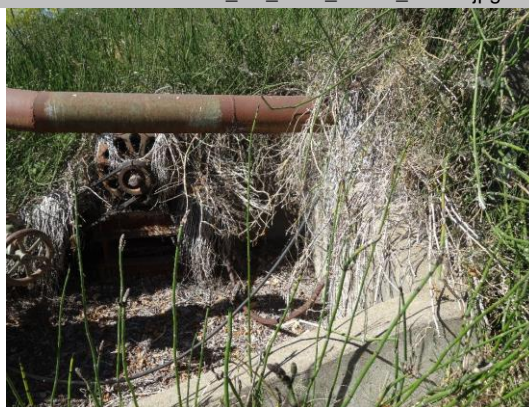
Photo 2 of 3 : UCIP_SP_2019_20267_34238.jpg

WS view: steel pipe and pump on concrete pad. Seems abandoned.

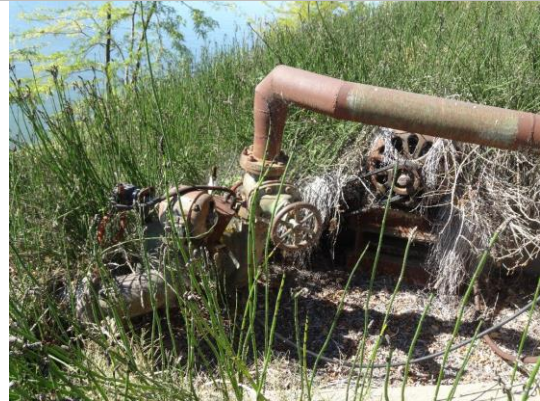
Photo 3 of 3 : UCIP_SP_2019_20267_34237.jpg

Comment Code						
Inspector Comment						
FS_ID:20267 DS_ID:22418 EP_NO: N/A Repair Type: Non-Urgent Crossing Status: Found UCIP Comments: - Abandoned pipe and pump.- Needs proper abandonment. FIELD_STRUCT_DESC: 6-inch steel irrigation discharge pipe and a 1-inch electrical conduit through the levee, invert elevation 3.5 feet below the crown. Pump and gate valve on the waterside (WS) slope. Electrical box on the WS slope. (Retention of an irrigation pumping plant, centrifugal pump, and gate valve on the WS with a 6-inch pipe through the levee authorized under Permit No. 9447, 1974 - Reuben A. Gentner). [Additional Reference(s): DWR Levee Log, 2005. USACE Sacramento O&M Manual 112, March 1957, (RM 34.47)]. FS Date: 8/27/2013

WS view: steel pipe, gate valve, and pump on levee slope. Seems abandoned.

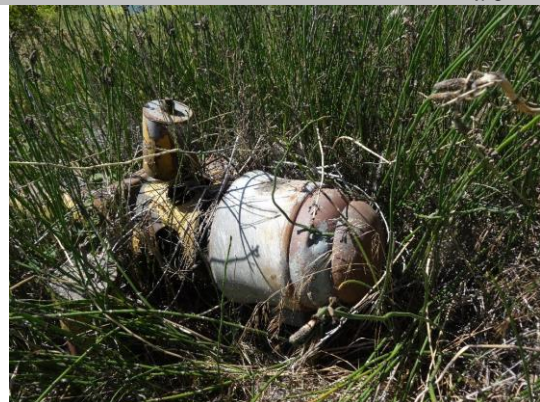
Photo 1 of 2 : UCIP_SP_2019_20284_34265.jpg

LM Start	0.48	Rating **	M	Issue No.	994
LM End	0.48	Issue Type +	En	Location *	
Category	Supplemental			GPS Latitude/Longitude	
				Start	End
Item	DWR UCIP Field Study			38.333754 °	38.333754 °
				-121.571018 °	-121.571018 °
DWR ID	22419				
Comment Code					
Inspector Comment					
FS_ID:20284 DS_ID:22419 EP_NO: N/A Repair Type: Non-Urgent Crossing Status: Found UCIP Comments: Needs proper abandonment. FIELD_STRUCT_DESC: 8-inch steel irrigation discharge pipe through the levee, invert elevation 5.7 feet below the crown. Power line on the landside (LS). (Retention of an irrigation pumping plant, a centrifugal pump, and an 8-inch steel pipe through the levee with a gate valve at the waterside [WS] end authorized under Permit No. 9446, 1974 - Hanna Olsen). [Additional Reference(s): DWR Levee Log, 2005. USACE Sacramento O&M Manual 112, March 1957, (RM 34.49)]. FS Date: 8/27/2013

WS view: abandoned pump on levee slope. Dense vegetation on waterside.

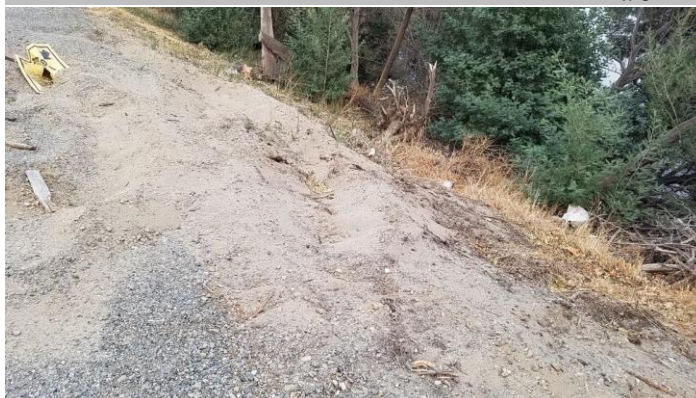
Photo 1 of 1 : SP_2019_RD0150_16_45_20190307_00018.jpg

LM Start	0.59	Rating **	M	Issue No.	45
LM End	0.59	Issue Type +	Ma	Location *	WS
Category	Earthen Levee			GPS Latitude/Longitude	
				Start	End
Item	Slope Stability			38.334898 °	38.334898 °
				-121.569632 °	-121.569632 °
DWR ID	DWR_RD0150_02_f_2018_45				
Comment Code					
S3 : Repair the levee slope damaged by vehicle traffic and prevent access where possible.					
Inspector Comment

View of slope damage likely from vehicle traffic. Fall 2018

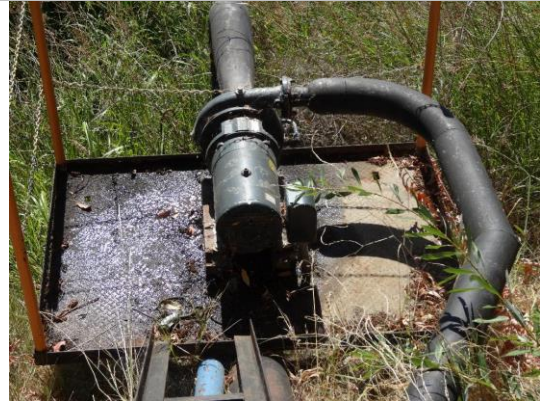
Photo 2 of 3 : UCIP_SP_2019_20303_34286.jpg

Comment Code						
Inspector Comment						
FS_ID:20303 DS_ID:22421 EP_NO: 16109 Repair Type: Non-Urgent Crossing Status: Found UCIP Comments: - 10" steel pipe on both sides of the levee. According to permit and inspectors note- 16" steel pipe through the levee.- concrete standpipe inside water filtration plant on landside toe.- air pressure tank on waterside steel deck. FIELD_STRUCT_DESC: 16-inch wrapped steel irrigation discharge pipe and a 2-inch electrical conduit through the levee, invert elevation 6.2 feet below the crown. Slant pump on a steel platform on the waterside (WS) slope. 4-inch abandoned pipe on the WS slope. Concrete standpipe and power pole at the landside (LS) toe. (Plans to replace an existing irrigation pipe with a 16-inch wrapped steel pipe through the levee, construct a 3-foot-square concrete anchorage block on the WS slope, and install a 2-inch utility pipe through the levee authorized under Permit No. 18258-Revised, 2007 - Wilson Farms, Inc). [Additional Reference(s): DWR Levee Log, 2005, 14-inch pipe referenced. USACE Sacramento O&M Manual 112, March 1957, (RM 34.71), 14-inch pipe referenced]. FS Date: 8/27/2013

WS view: steel pipes and leaky slant pump on steel deck.

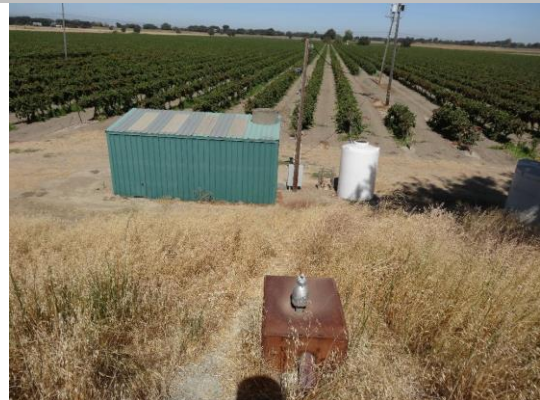
Photo 3 of 3 : UCIP_SP_2019_20303_34285.jpg

LS view: 10-inch pipe and air vent on levee slope. Concrete standpipe inside water filtration plant.

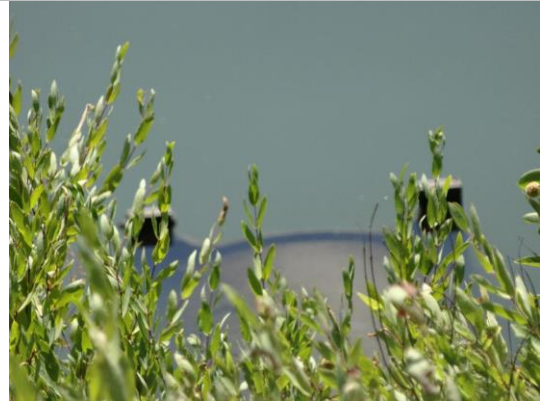
Photo 3 of 3 : UCIP_SP_2019_20727_34887.jpg

WS view: submerged flap gate in the stream.

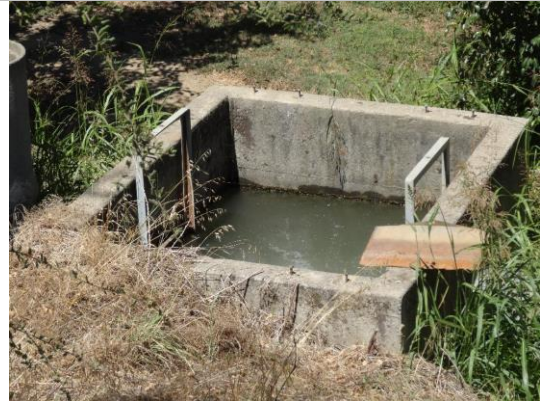
Photo 3 of 3 : UCIP_SP_2019_20348_34369.jpg

LS view: concrete distribution box on levee toe.

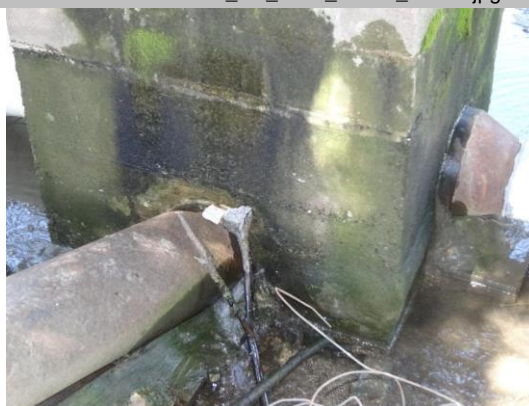
Photo 3 of 3 : UCIP_SP_2019_20731_34903.jpg

LS view: leaky concrete distribution box on levee toe.

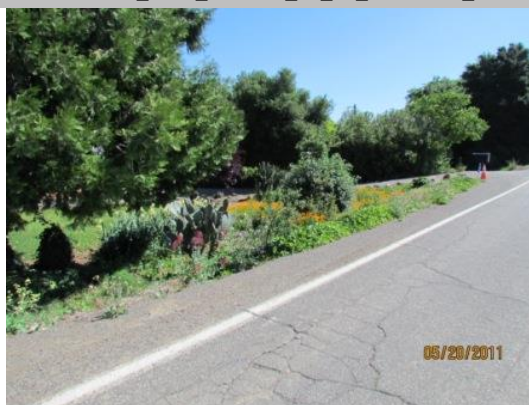
Photo 1 of 1 : SP_2019_RD0150_16_88_20190307_00057.jpg

Unpermitted landscaping was found on the landside slope of the levee.
The picture was taken from the crown looking upstream. Spring 2011

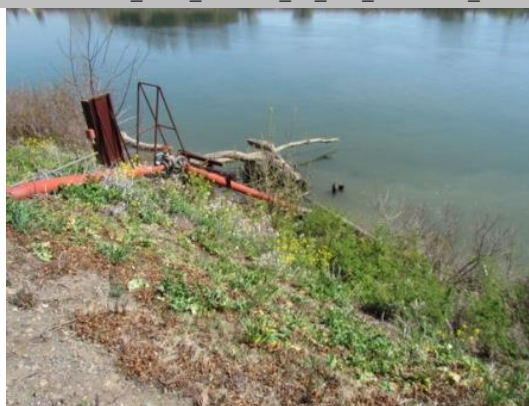
Photo 3 of 5 : SP_2019_RD0150_16_961_20190307_00068.jpg

View of the erosion on the waterside slope of the levee looking upstream during spring 2013 inspection.

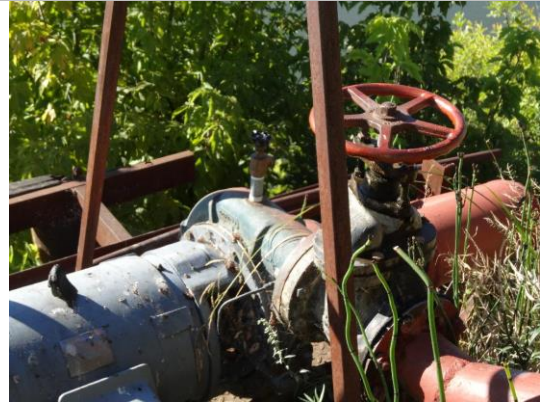
Photo 3 of 3 : UCIP_SP_2019_20736_34915.jpg

WS view: pipe and pump on levee slope. Gate valve and air vent on the pipe.

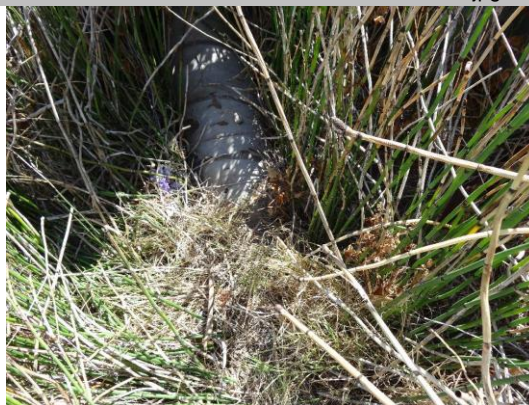
Photo 2 of 3 : UCIP_SP_2019_42702_33781.jpg

WS view: exposed 14-inch steel pipe on levee slope.

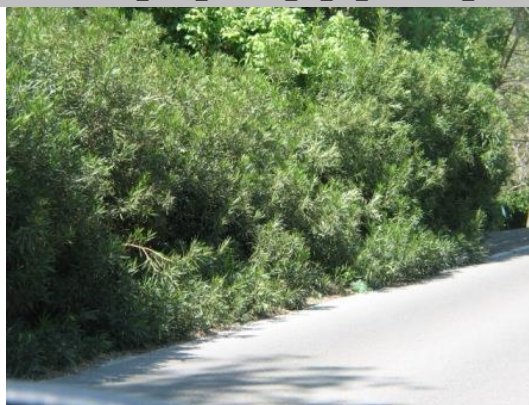
Photo 1 of 1 : SP_2019_RD0150_16_24_20190307_00010.jpg

View of landscaping (Oleander) on landward slope.

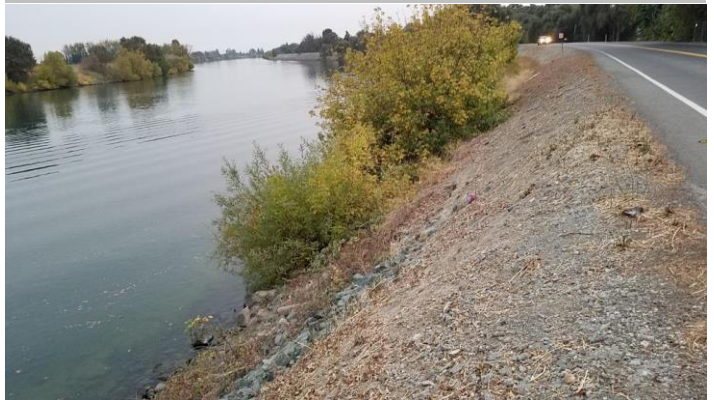
Photo 1 of 4 : SP_2019_RD0150_16_50_20190307_00027.jpg

View of waterside slope with some revetment. Fall 2018

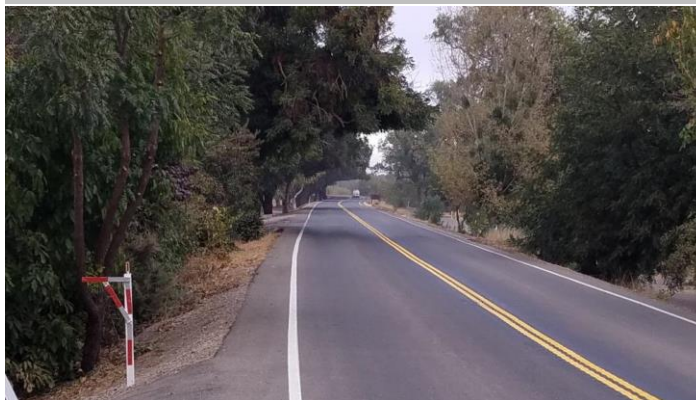
Photo 1 of 1 : SP_2019_RD0150_16_74_20190307_00049.jpg

View of dense landscaping on levee slope. Fall 2018

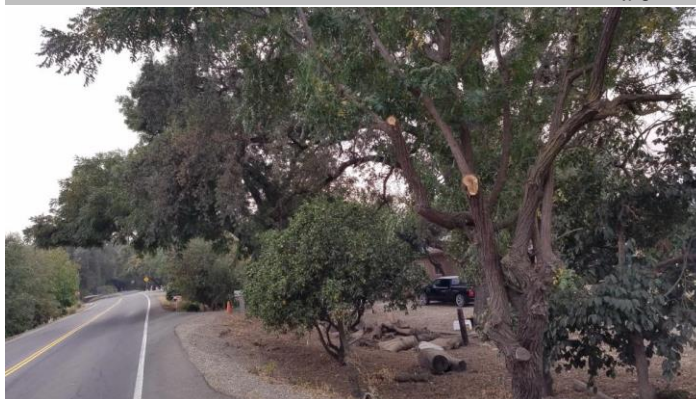
Photo 1 of 1 : SP_2019_RD0150_16_86_20190307_00056.jpg

View of firewood at levee toe and fruit tree on levee slope. Fall 2018

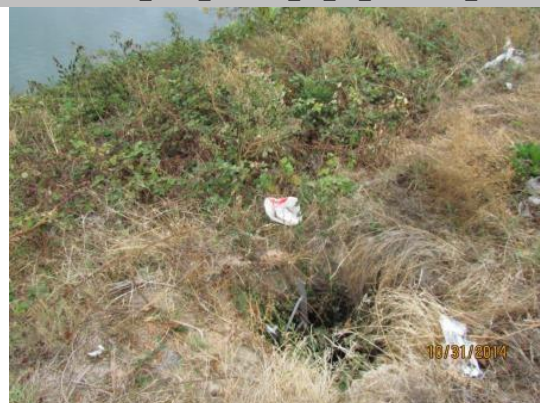
Photo 1 of 1 : SP_2019_RD0150_16_55_20190307_00038.jpg

An open pipe valve was found without a cover on the waterside toe of the levee. Fall 2014

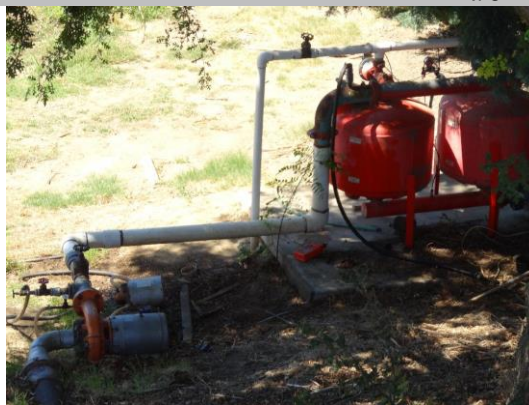
Photo 2 of 2 : UCIP_SP_2019_41720_34080.jpg

LS view: concrete vault, pipe, and pump in water filtration plant.

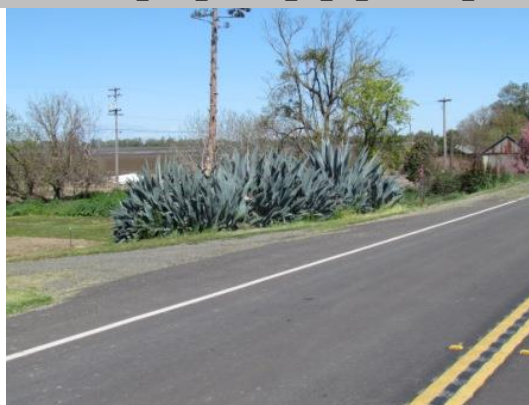
Photo 1 of 1 : SP_2019_RD0150_16_43_20190307_00017.jpg

Century plants were found on the landside of the levee looking upstream.

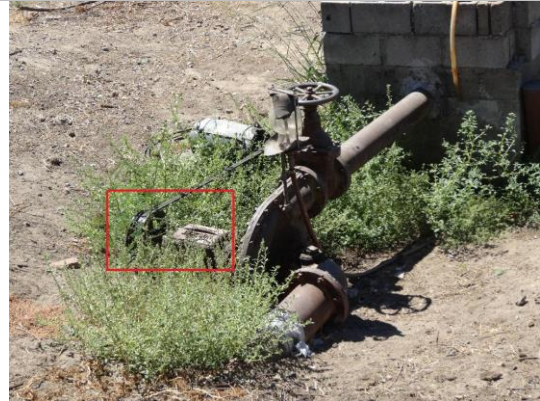
Photo 3 of 3 : UCIP_SP_2019_41646_34100.jpg

LS view: concrete masonry distribution box (top), steel pipe, gate valve, air vent, and pump (left) on levee toe.

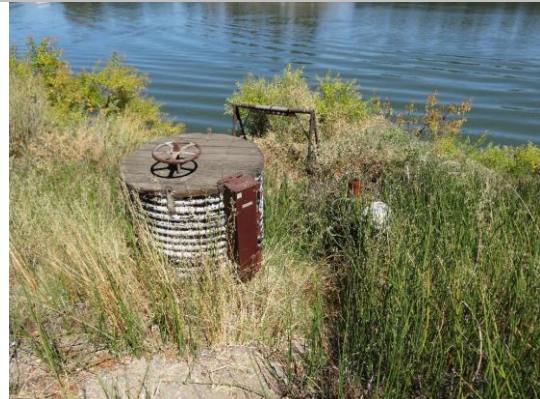
Photo 1 of 3 : UCIP_SP_2019_53333_34162.jpg

WS view: CMP riser with slide gate and pump (right) on levee slope.

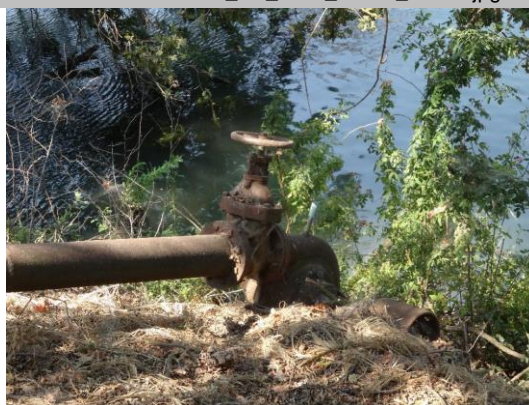
Photo 1 of 3 : UCIP_SP_2019_42694_32005.jpg

WS view: pipe and pump on levee slope.

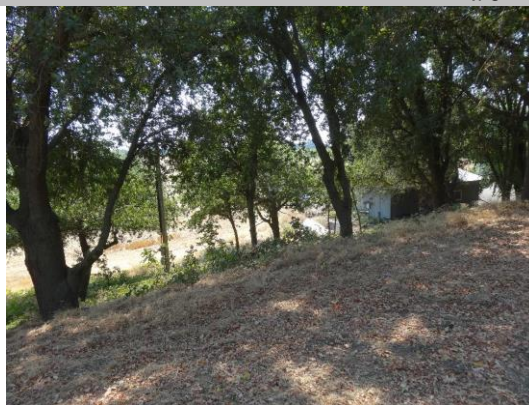
Photo 2 of 3 : UCIP_SP_2019_42693_31978.jpg

LS view: no pipe on levee slope.

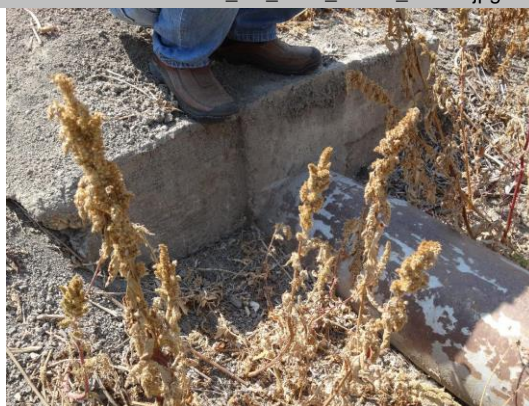
Photo 2 of 3 : UCIP_SP_2019_19112_32043.jpg

WS view: concrete headwall and exposed pipe on levee slope.

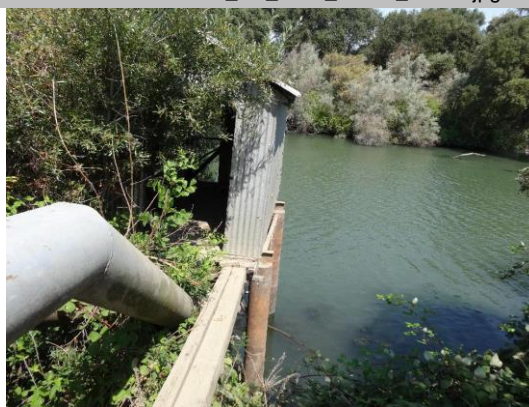
Photo 3 of 3 : UCIP_SP_2019_19112_32042.jpg

WS view: pipe, wooden walkway and pump house in channel.

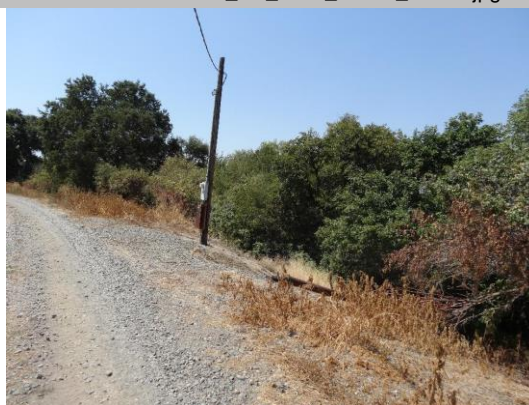
Photo 1 of 3 : UCIP_SP_2019_19137_32108.jpg

WS view: exposed pipe and power pole on levee slope.

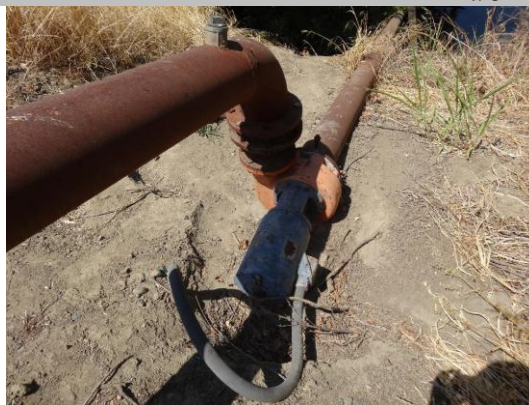
Photo 3 of 3 : UCIP_SP_2019_19137_32106.jpg

WS view: pipe and slant pump on levee slope.

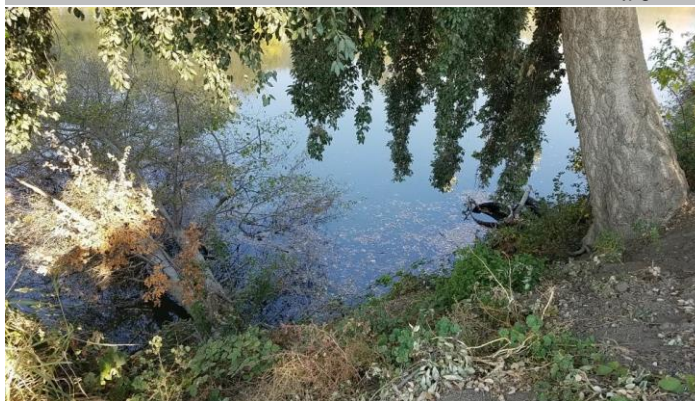
Photo 1 of 4 : SP_2019_RD0150_17_37_20190307_00019.jpg

View of slope damage near fallen tree. Fall 2018

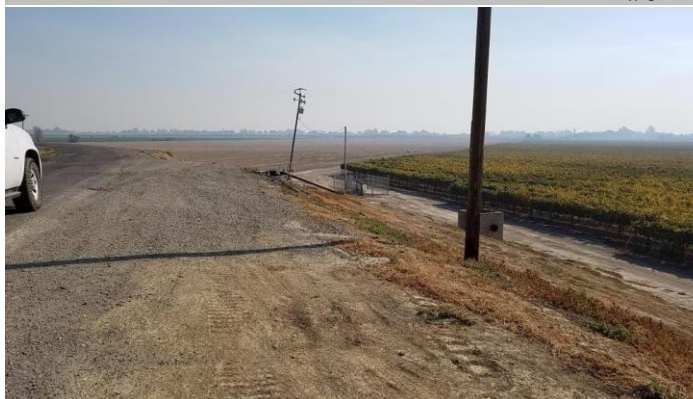
Photo 1 of 1 : SP_2019_RD0150_17_113_20190307_00097.jpg

View of unused pole on the levee slope. Fall 2018

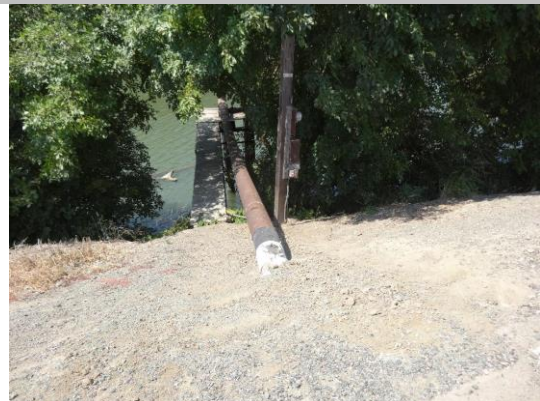
Photo 1 of 3 : UCIP_SP_2019_53334_35013.jpg

WS view: exposed pipe, walkway, service pole on levee slope and pump support in channel.

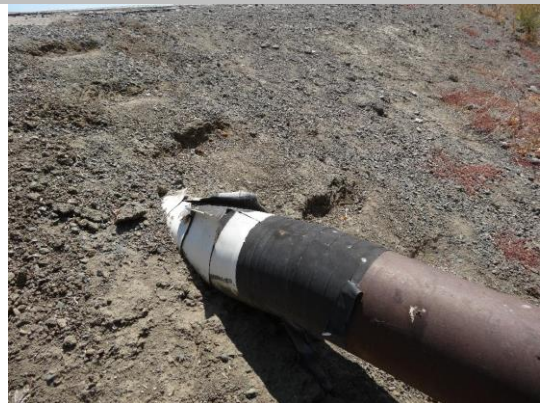
Photo 3 of 3 : UCIP_SP_2019_53334_35011.jpg

LS view: exposed pipe on levee slope.

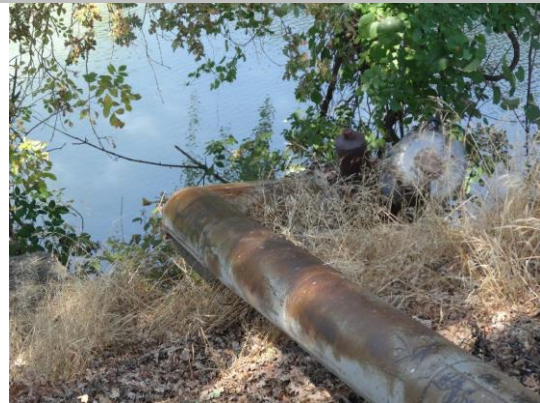
Photo 1 of 3 : UCIP_SP_2019_50202_35018.jpg

WS view: steel pipe and pump on levee slope.

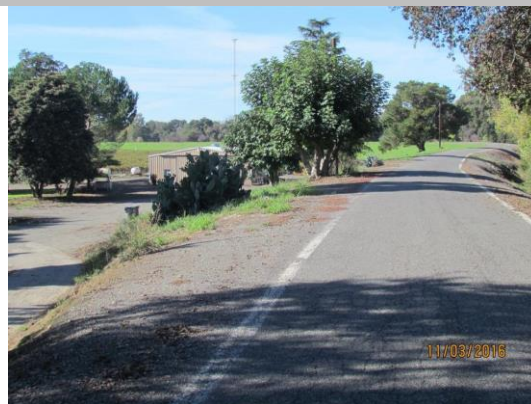
Photo 1 of 1 : SP_2019_RD0150_17_94_20190307_00080.jpg

View of landscape on the landside shoulder of the levee. Fall 2016

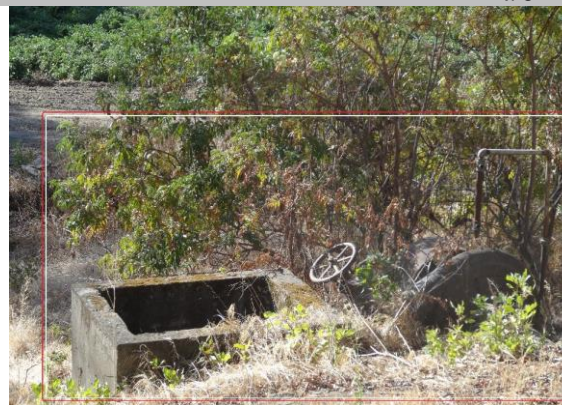
Photo 2 of 3 : UCIP_SP_2019_19283_32564.jpg

LS view: abandoned pump set and concrete box on levee slope.

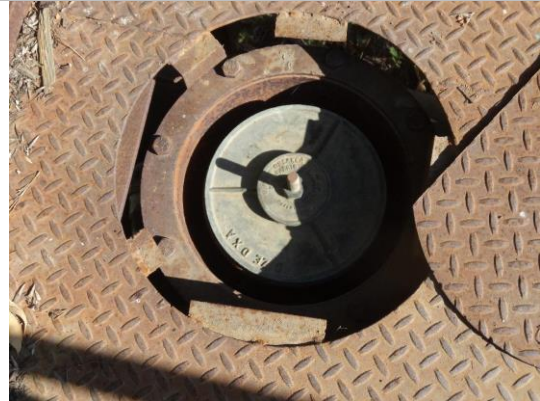
Photo 3 of 3 : UCIP_SP_2019_49386_63900.jpg

WS view: siphon breaker on pipe in steel deck on stream bank.

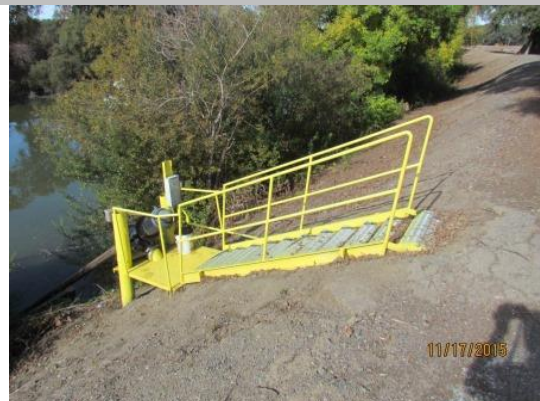
Photo 1 of 1 : SP_2019_RD0150_17_48_20190307_00033.jpg

View of a stairway on the waterside of the levee. Fall 2015

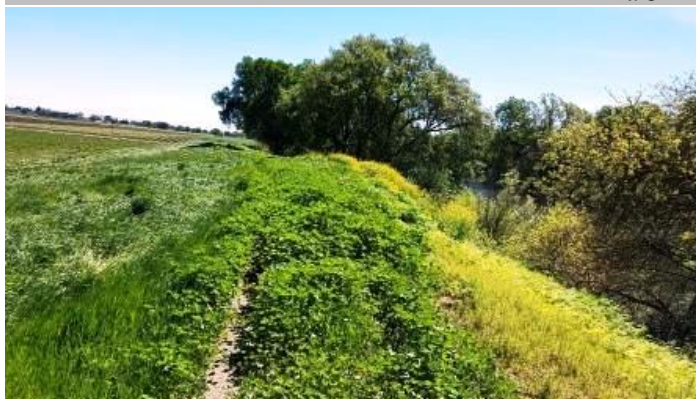
Photo 1 of 1 : SP_2019_RD0150_17_154_20190415_00176.jpg

View of tall vegetation on levee crown. Spring 2019

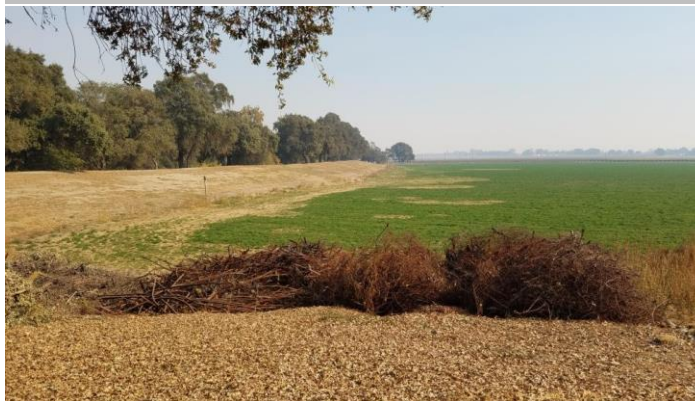
Photo 1 of 1 : SP_2019_RD0150_17_39_20190307_00023.jpg

View of landowner's metal debris at levee toe. Fall 2018

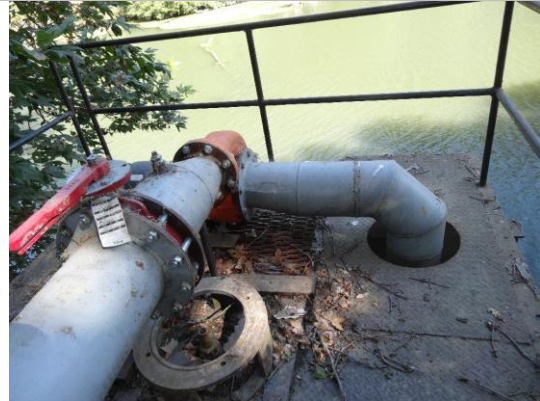
Photo 3 of 3 : UCIP_SP_2019_28265_51972.jpg

WS view: pipe, pump and gate valve on pump deck.

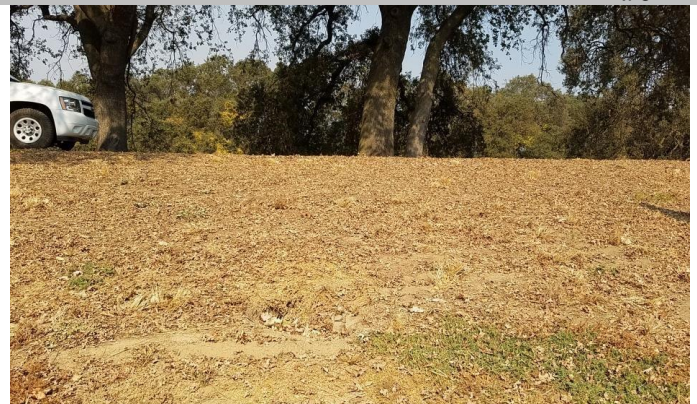
Photo 1 of 2 : SP_2019_RD0150_17_104_20190307_00089.jpg

View of animal hole on landside toe. Fall 2018

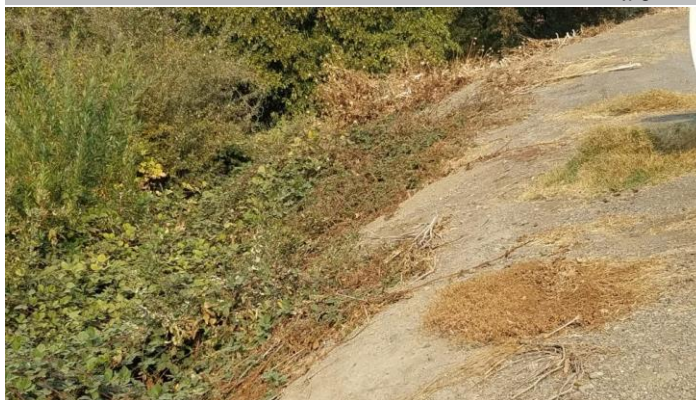
Photo 1 of 1 : SP_2019_RD0150_17_46_20190307_00032.jpg

View of wild growth within levee easement. Fall 2018

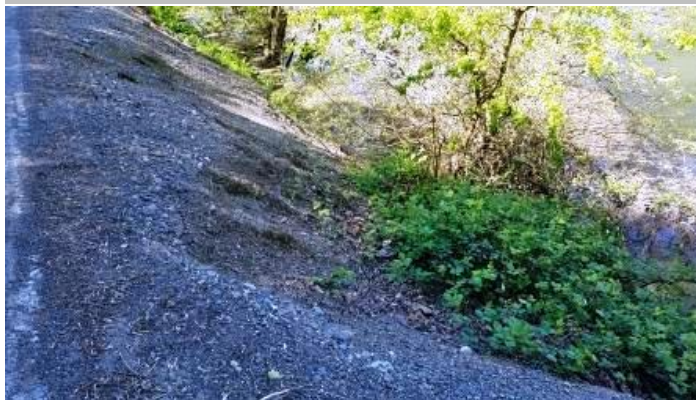
Photo 1 of 2 : SP_2019_RD0150_17_61_20190415_00170.jpg

View of erosion on waterside slope. Spring 2019

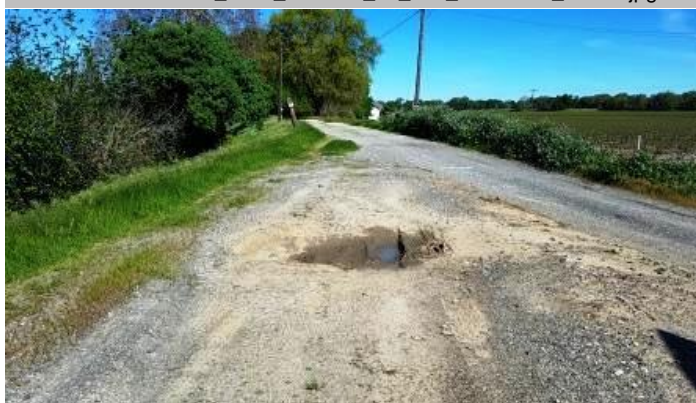
Photo 1 of 1 : SP_2019_RD0150_17_131_20190415_00169.jpg

View of pothole on levee crown. Spring 2019

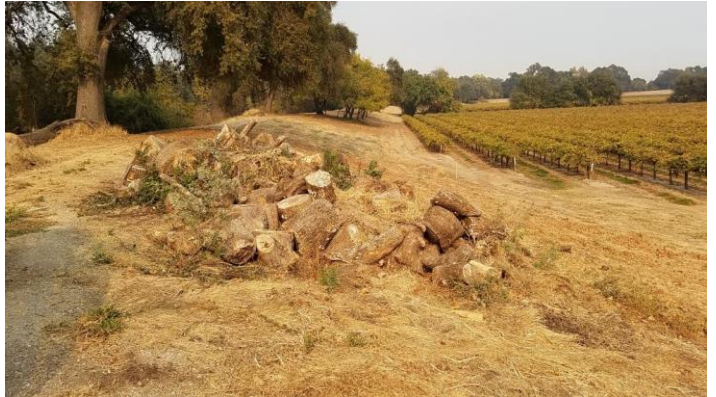
Photo 1 of 1 : SP_2019_RD0150_17_63_20190307_00051.jpg

View of firewood on levee shoulder. Fall 2018

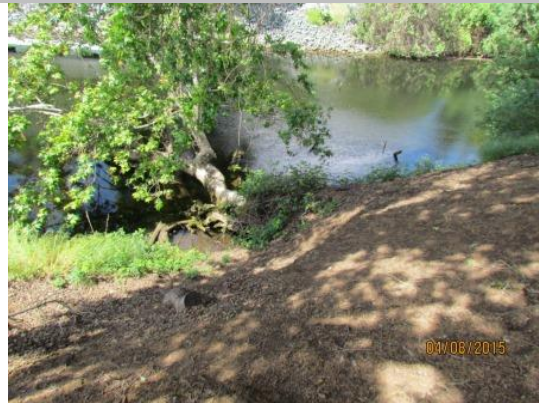
Photo 1 of 1 : SP_2019_RD0150_17_396_20190307_00118.jpg

Slope instability was found on the waterside toe of the levee looking upstream. Spring 2015

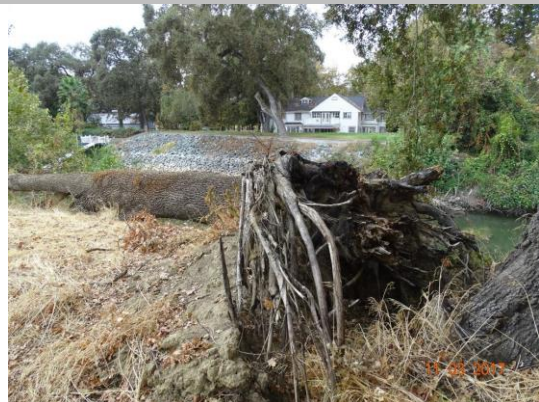
Photo 1 of 1 : SP_2019_RD0150_17_129_20190307_00117.jpg

View of a tree stump on the waterside shoulder of the levee. Fall 2017

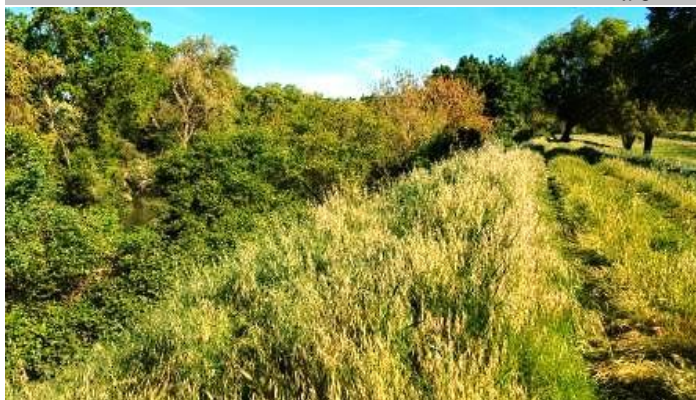
Photo 1 of 1 : SP_2019_RD0150_17_38_20190415_00167.jpg

View of tall waterside vegetation. Spring 2019

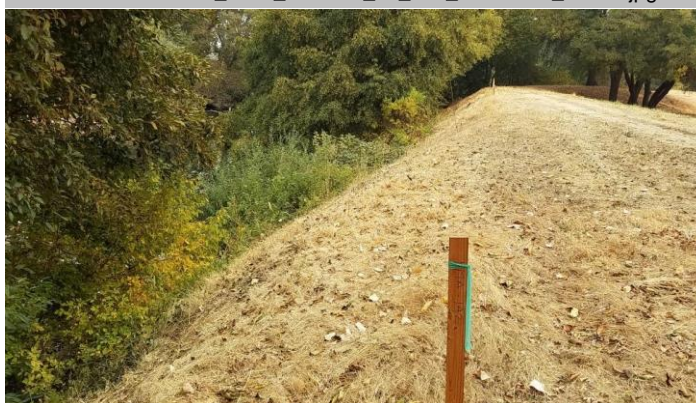
Photo 1 of 4 : SP_2019_RD0150_17_122_20190307_00108.jpg

View of waterside slope. Fall 2018

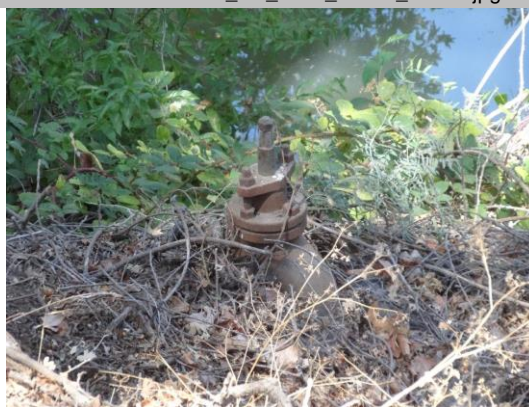
Photo 2 of 3 : UCIP_SP_2019_53335_33626.jpg

WS view: abandoned gate valve found on levee slope.

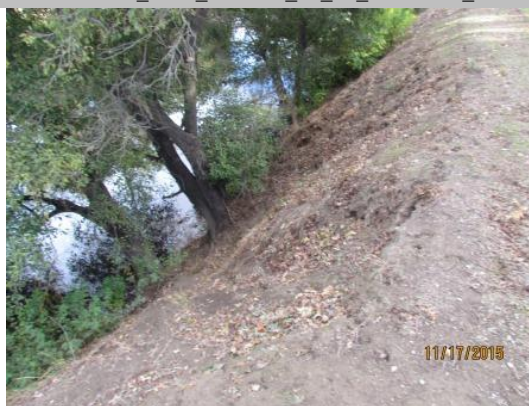
Photo 1 of 1 : SP_2019_RD0150_17_65_20190307_00053.jpg

View of erosion on the waterside of the levee. Fall 2015

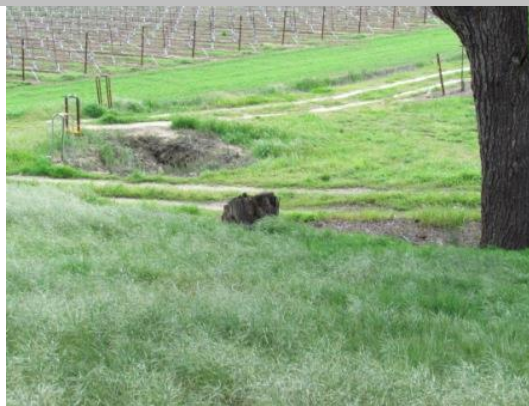
Photo 1 of 1 : SP_2019_RD0150_17_90_20190307_00073.jpg

A tree stump was found on the landside of the levee looking upstream.

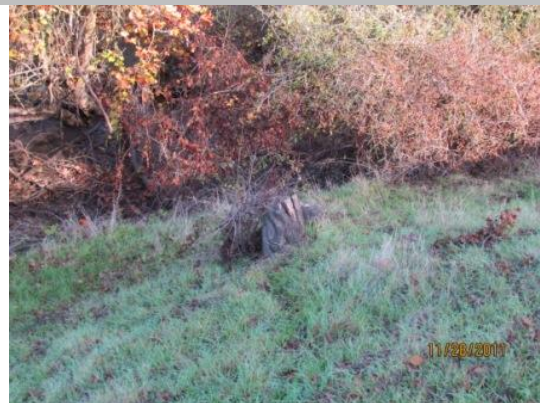
Photo 1 of 1 : SP_2019_RD0150_17_59_20190307_00046.jpg

A tree stump was found on the waterside of the levee looking upstream.
Fall 2011
